Holtec International: Cask Change Control and Corrective Action Concerns

November 2021

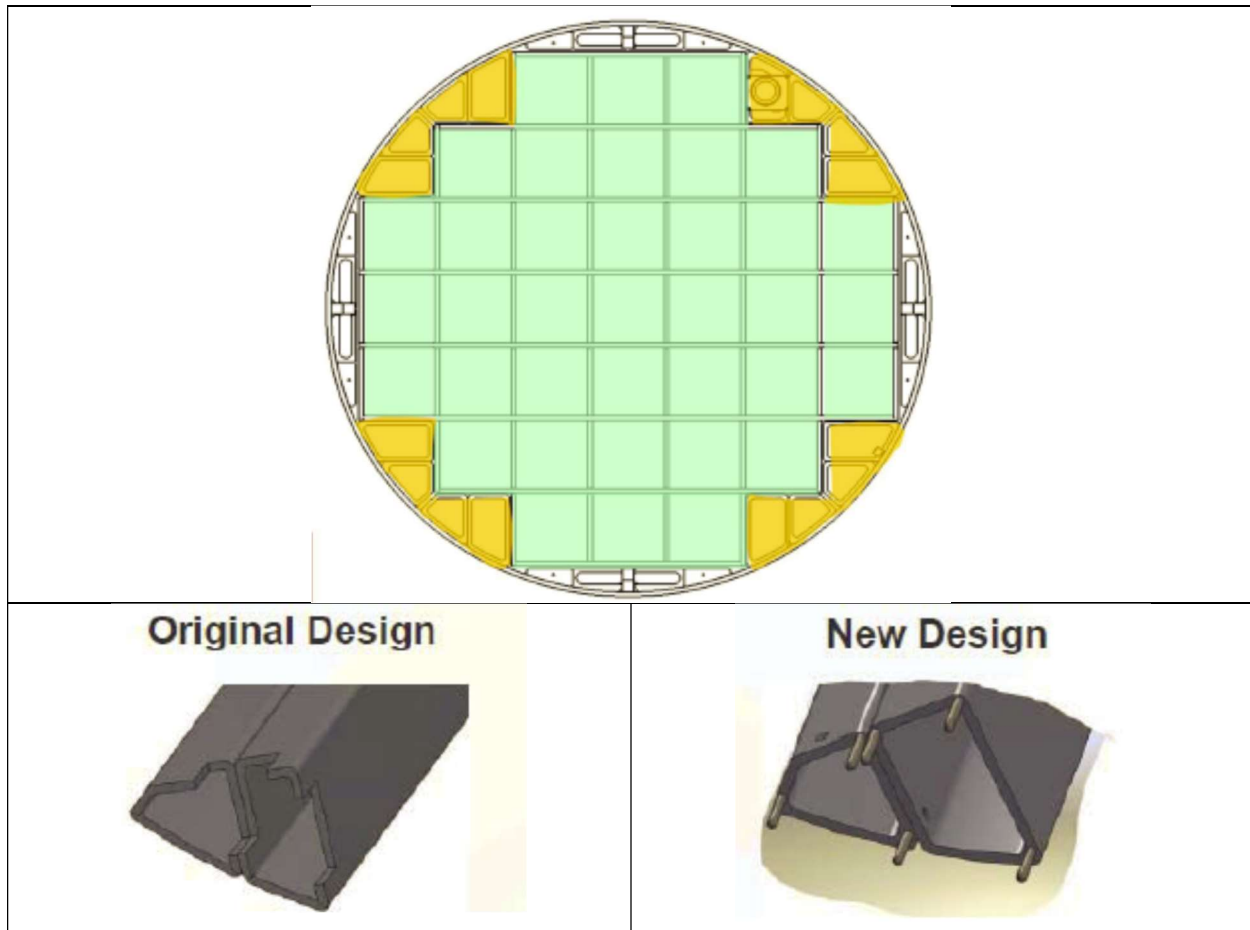
A few months earlier in 2019, the NRC issued another violation of 72.48 for unapproved changes identified during the receipt inspection of another cask at San Onofre in California. The NRC reported that Holtec modified the design of shims installed within spent fuel canisters in August 2016. The shims (shaded in yellow in the top graphic below) are inserted in the irregular shaped spaces between the cylindrical canister and the square-edged baskets holding fuel assemblies.⁸

In the original shim design, rectangular regions of the bottom edges were machined away to provide pathways for the inert gas within a loaded canister to circulate and aid in transferring the decay heat generated by spent fuel assemblies out of the canister.

In the modified design, stainless steel pins were inserted in the flat bottom edges of the shims to provide “legs” that created the same gas flow pathway.

In February 2018, workers at the San Onofre nuclear plant in California identified a broken shim pin. The NRC’s ensuing investigation concluded that Holtec improperly revised the shim design without first obtaining the NRC’s approval:
